## 2009-2010 DTM Project, Mississippi

# INDEPENDENT QUALITY CONTROL REPORT

## Independent Quality Control Report

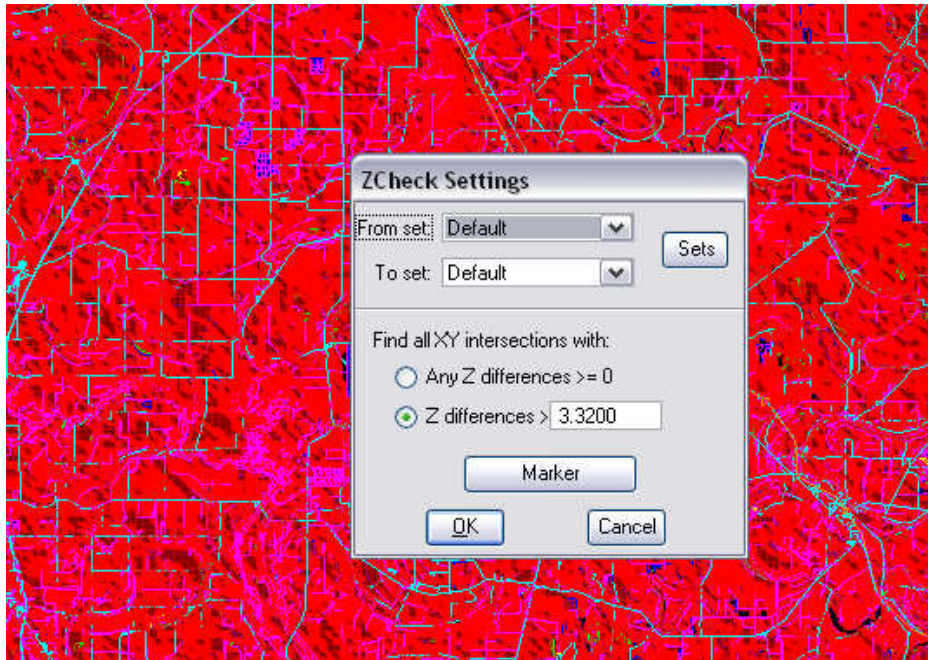
**Figure 3 - Example of automated vertical difference check**

Figure 3 depicts an example of a crossing feature check used to search for vertical difference between nearest-neighbors or crossing features exceeding +/- 3.32 ft.

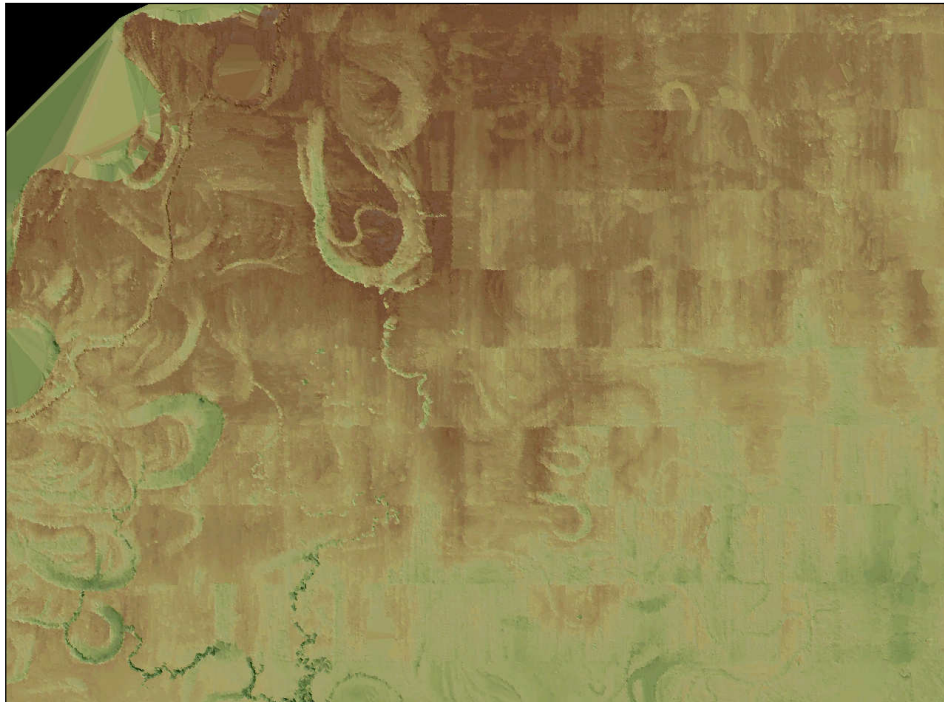
Figure 11- TIN surface of a block of source DTM files illustrating elevation steps

The table 1 outlines the elevation steps identified in the initial deliveries of source DTM files:

Figure 11 illustrates the visibility of the elevation steps using a simple TIN for review of the source DTM.

Issues identified during this QA process were corrected by FEDI and redeliveries were checked to verify the corrections.

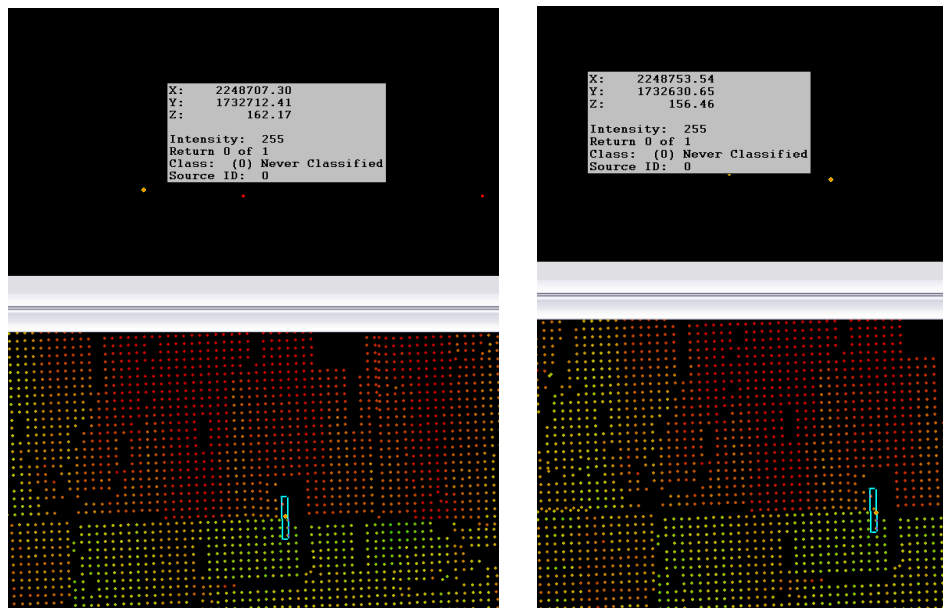
Figure 12 - Cross section showing a difference of ~5 ft between the top and bottom of the step

Cross sections such as the one in Figure 12 were used along identified seamlines to quantify the severity of each step and whether or not the vertical difference observed was within project specifications or not.

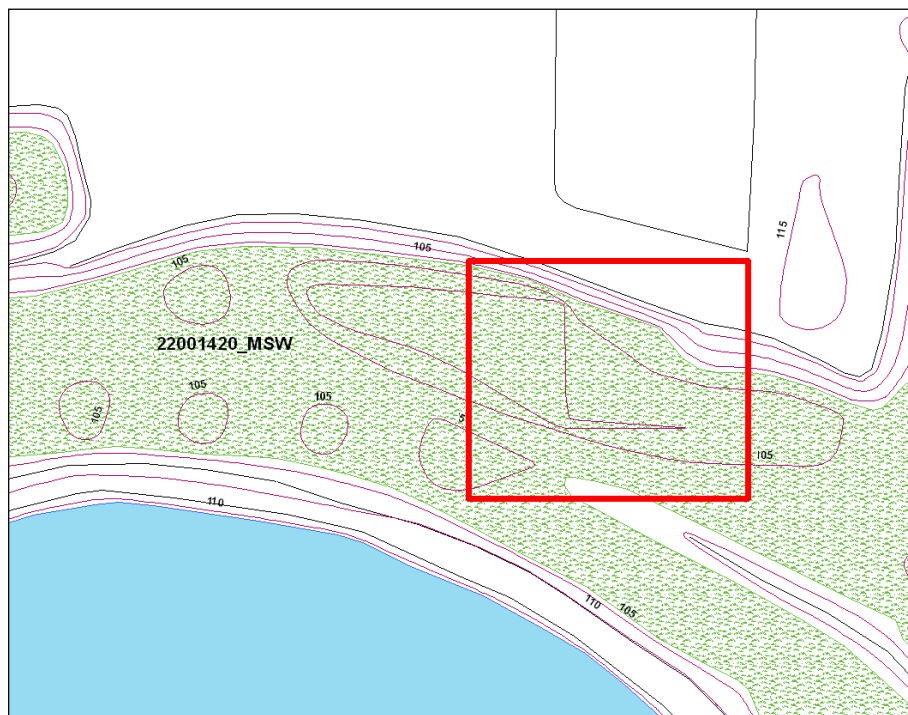
1. *Anomalous contours* – reviews of the delivered geodatabases identified instances of anomalous looking contours which would indicate that the area is not correctly depicted by the contours and possibly the DTM. Figures 13-17 are examples of identified contour anomalies identified during the QA.

Figure 13 - Anomalous contour; tile 22001420\_MSW

Issues identified during this QA process were corrected by FEDI and redeliveries were checked to verify the corrections.

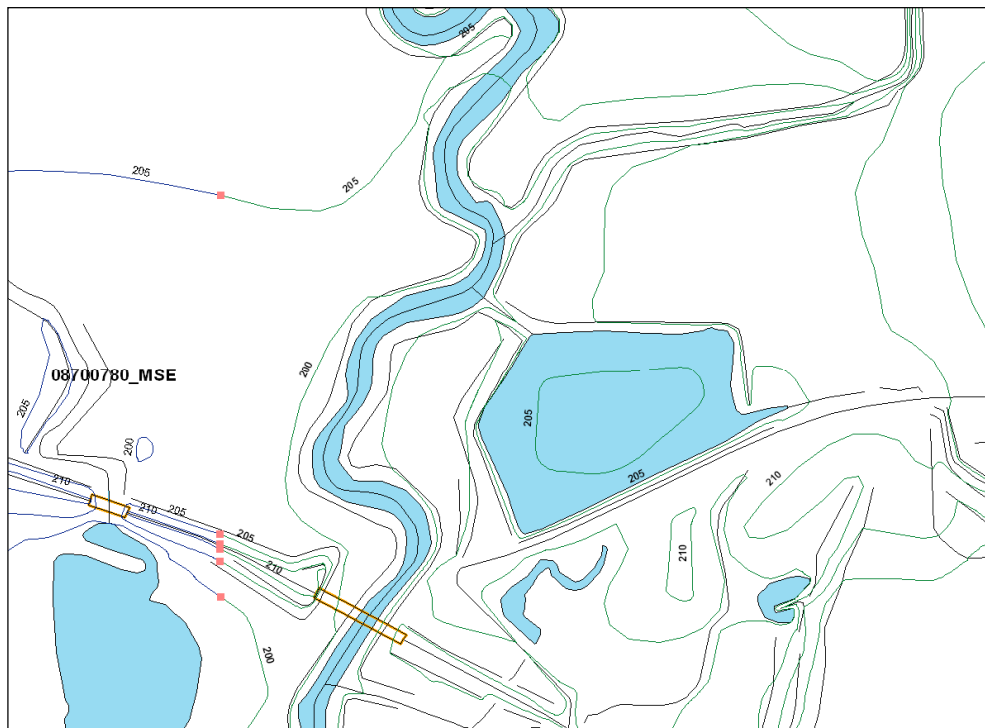
2. *Contours located within water bodies* – initial geodatabase deliveries contained errors in the contour files consisting of contour lines located within closed water bodies. Figures 18-20 are examples of this issue.

Figure 18 - Example of contour within closed water body; tile 08700780\_MSW

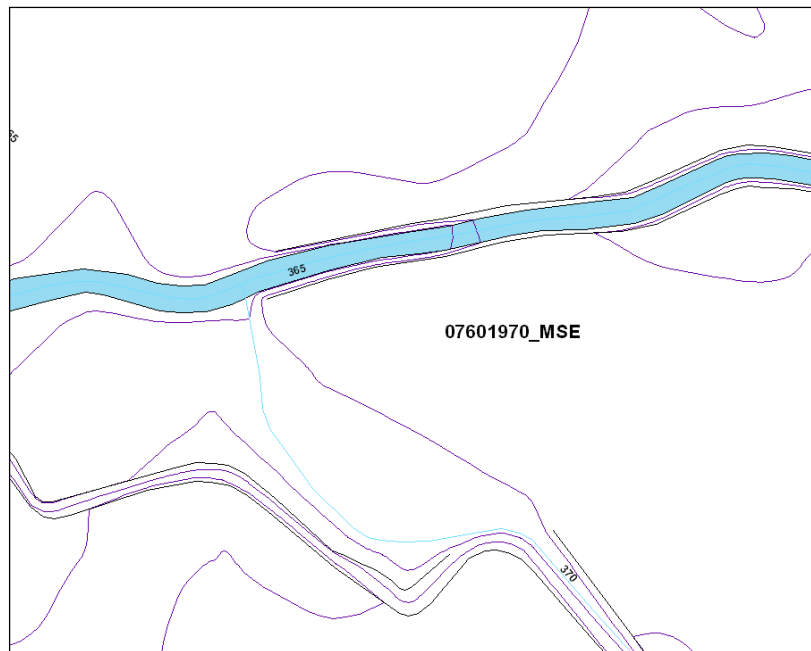
3. *Double contours crossing rivers* – Double contours of varying elevations were found in several locations that would erroneously indicate a severe drop in

elevation at the crossing (such as a dam or waterfall). In some instances, these were identified as being caused by temporal differences in the imagery where flooding had occurred. However, some of the calls were valid as errors. Figures 21-22 are examples of this issue.

**Figure 21 - Double contours crossing river; tile 07601970\_MSE**

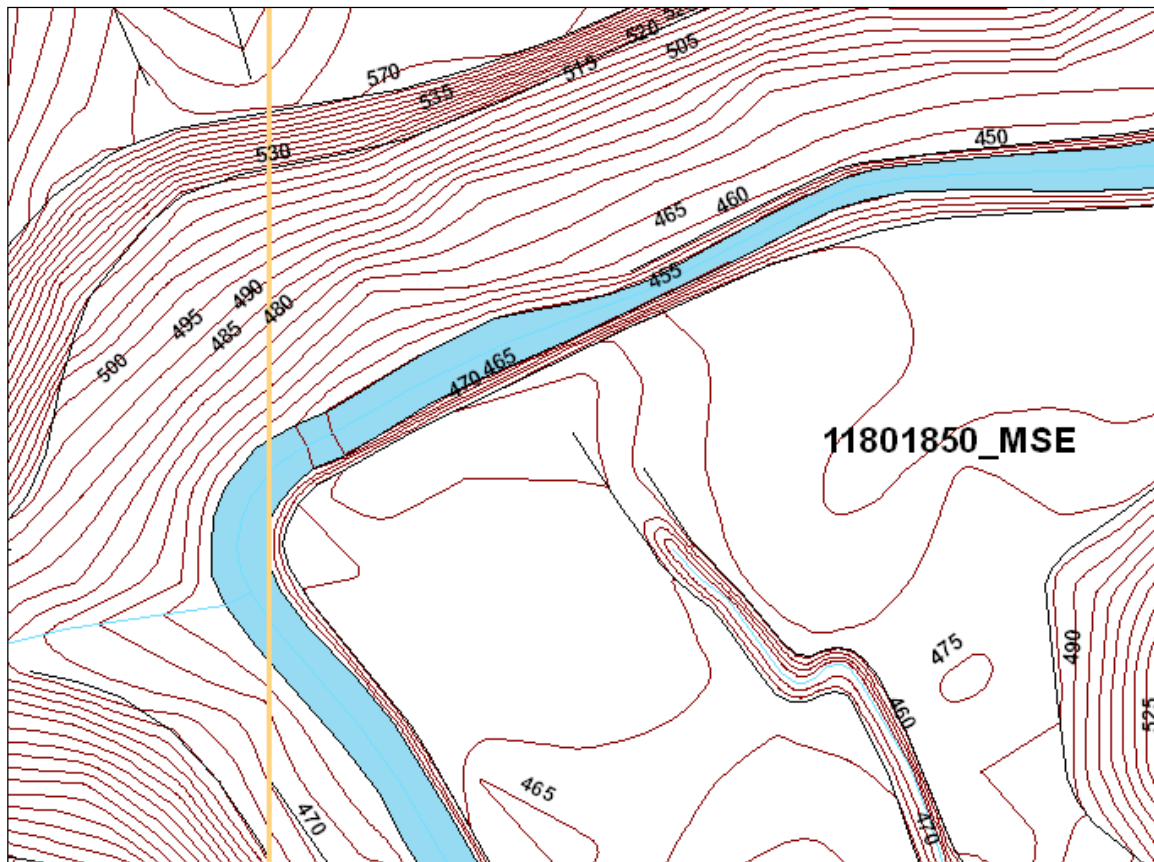
Figure 22 - Double contours crossing river; tile 11801850\_MSE

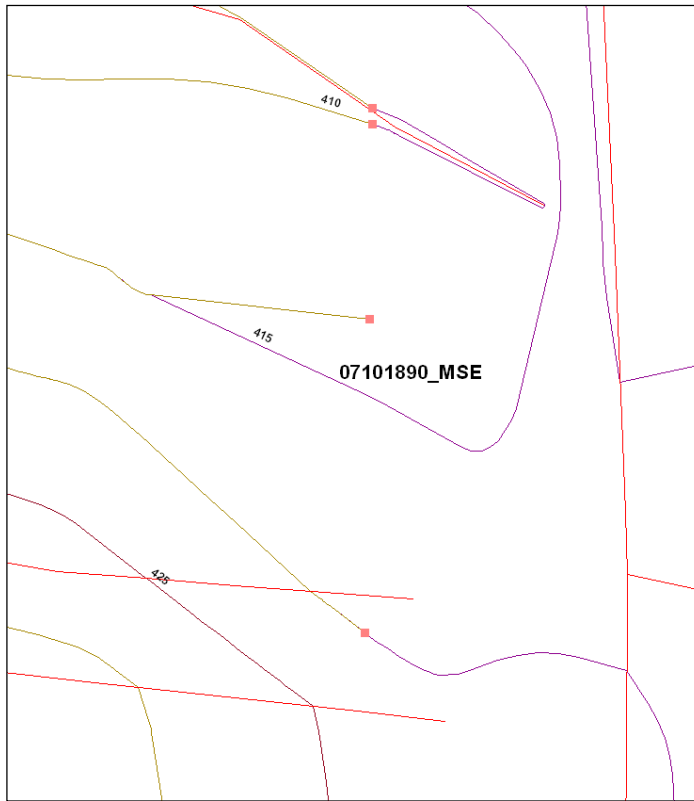
4. *Overshoots/dangles and gaps in contours* - QA of the seamlines along adjoining blocks and contour files identified issues with the seamless transition of contours over the edges of blocks and/or files. These included:
  - a. *Overshoots/dangles* - where the end of a contour from one area connects to but overshoots the identical contour in the adjoining area
  - b. *Gaps* where a contour is broken by a block or file edge

Figure 23 - Example of contours containing overshoots/dangles. Yellow contours are from contour file adjoining the purple contours; tile 07101890\_MSE
